Preparations for field testing for the performance validation of piled wind turbine foundations in expansive clays

ABSTRACT: Field-testing of piles in an expansive clay is required for the validation of the design criteria for wind turbine foundations in such soil profiles. The test programme includes lateral load tests to investigate the horizontal stiffness of the soil and vertical plug pull-out tests to examine the axial capacity of pile-soil interface. These tests will be conducted in both dry and wet conditions to study the range of expected responses of the pile and evaluate how the changing soil moisture condition affects the pile behaviour. In addition, an instrumented pile socketed into bedrock will be used to determine the strain induced in the pile due to soil heave as the soil saturation levels increase. For the execution of these tests, a large open area with expansive clay of a sufficient depth is required; a stable stratum below the clay is desirable for the socketing of the long piles. An important component of the investigation is the characterisation of the expansive clay profile. A preliminary site investigation has been carried out on the field-testing site whi

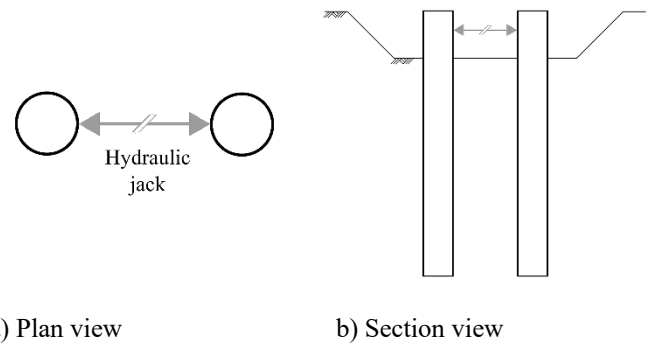
The pile load testing will be carried out by using a hydraulic jack and jacking two test piles against each other as shown in Figure 1. Each pile is monitored individually; in this way, two results are obtained from each test.

Figure 1. Layout of lateral pile load tests (not to scale)

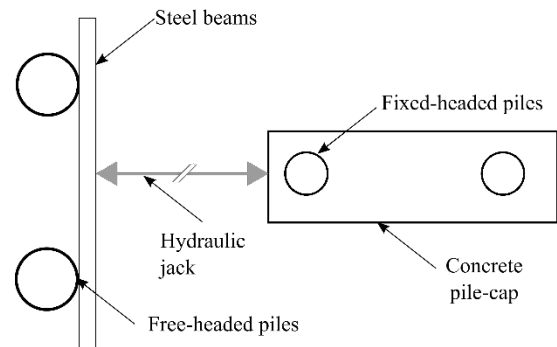
An additional test configuration is planned as shown in Figure 2 to test the pile and soil response for a fixed-headed pile as would be expected in the base of a wind turbine with a pile cap connecting all the piles. This will allow the comparison of the behaviour of the free head and fixed head piles.

Figure 2. Layout of grouped lateral pile load tests (not to scale)

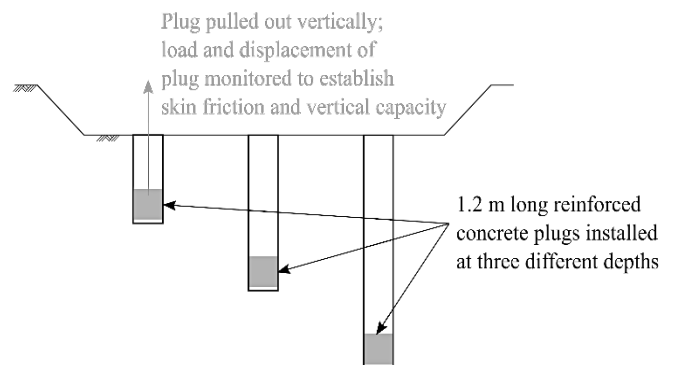
The vertical plug pull-out tests are planned to ascertain the maximum transfer of load from the heaving soil to the pile shaft at different depths in the profile at both NMC ('dry') and under soaked ('wet') conditions. The intention of these tests is to determine whether the shaft resistance will increase due to the increased lateral stress or will reduce due to softening of the clay on wetting. The proposed test set-up is shown in Figure 3. Three plugs at different depths will be tested to get an indication of the variance in the shaft resistance with depth. These results will enable the determination of the maximum pull-out forced exerted on the pile.

Figure 3. Schematic configuration of vertical plug-pull tests (not to scale)

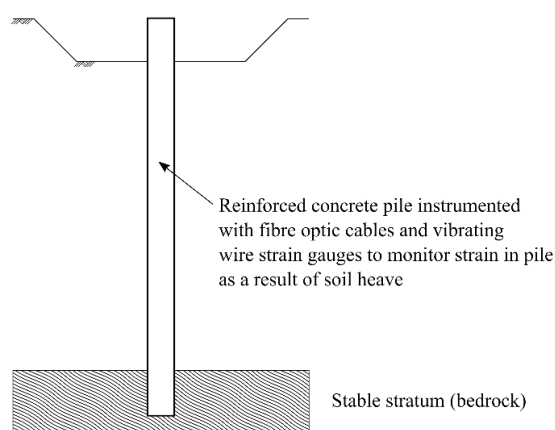
Two instrumented piles will be installed; a schematic example of one is shown in Figure 4. One pile will be subjected to accelerated heave by wetting the surrounding soil, and the second left to swell naturally and in response to seasonal moisture content changes. The strains in the pile will be measured using fibre optic cables and vibrating wire strain gauges cast in the pile.

Figure 4. Layout of grouped lateral pile load tests (not to scale)

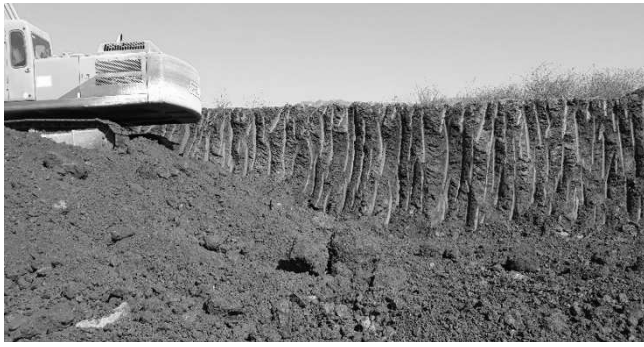
A visit was conducted to a potential site at the AttaClay mine which extracts attapulgite and bentonite clays by shallow surface mining. These minerals are processed and sold for use in applications such as binders, cat litter and dam sealing. A photograph of the clay quarry wall is shown in Figure 5; the excavator teeth mark on the sidewall give an indication of the stiffness of the clay profile. Evidence of cracking in buildings on site, an example of which is shown in Figure 6, indicates the expansive nature of the soil and thus the suitability for our project. Boreholes that had been drilled by the mine to 9 m depth indicated a clay profile to at least this depth.

Figure 5. Attapulgite and bentonite quarry wall at the AttaClay mine.

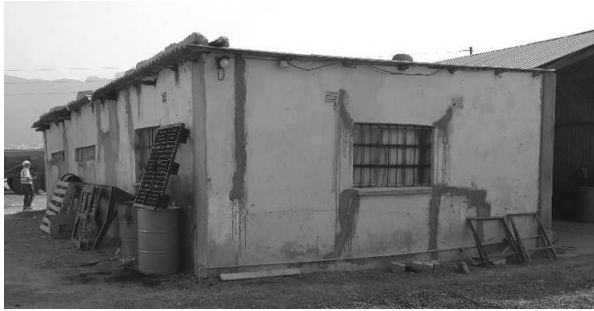
Figure 6. Cracked buildings on site showing evidence of expansive clays

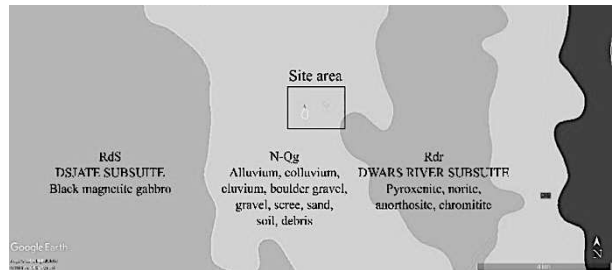
These figures show that the site is located in an alluvial plain between two formations of the Rustenburg Layered Suite of the Bushveld Complex: the mountains of the Dsjate Subsuite to the west and outcrops of the Dwars River Subsuite to the east.

Figure 8. Overlay of geological zones (Council for Geoscience 2019) over site location

As described by Williams et al. (1985), the expansive clay identified on site is likely to be a combination of residual soils formed from the weathering of the Rustenburg Layers Suite and active material transported from the weathering of the adjacent basic igneous rocks.

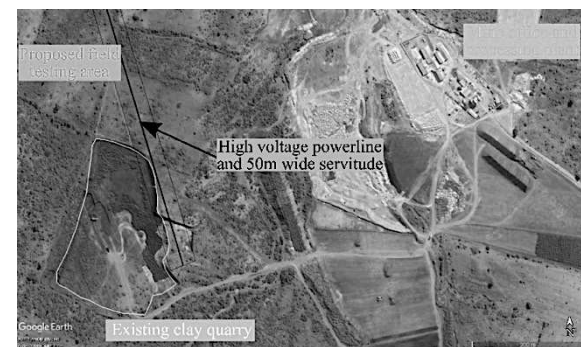
Figure 9. Existing clay quarry and mine area showing proposed field-testing area

Two tests pits were excavated at the end of the dry season to describe the soil profile in the proposed testing area north of the existing quarry (see Figure 9).

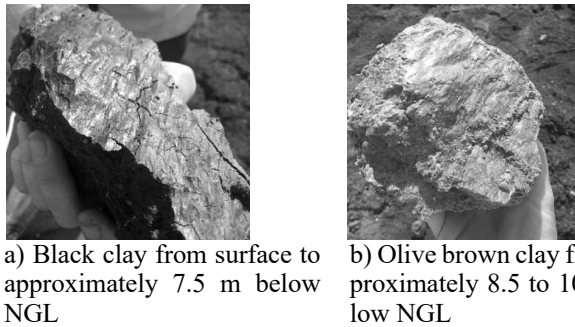
Significant fissuring and slickensiding was noted in all the clay material encountered in both test pits. Figure 10 shows photographs of blocks of clay removed from the spoils of the excavations; the smooth, shiny surfaces (slickensides) in the clay are evidence of movement along these planes due to cycles of wetting and drying confirming the expansiveness of the material.

Figure 10. Example of slickensided blocks of clay removed from the spoils of the test pit excavation

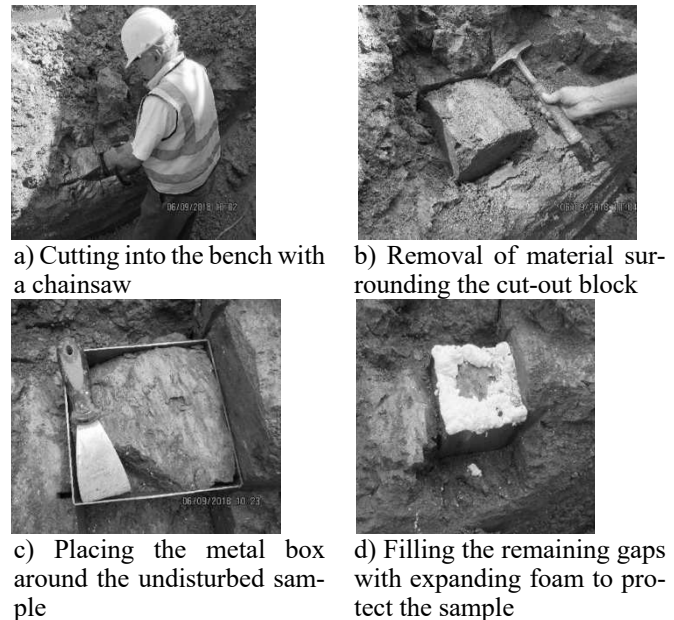
In TP1, the test pit was widened to create a bench about 1 m off the intermediate base of the pit. The chainsaw was used to cut into the soil from the top, loose material was removed, and the metal box was placed over the sample. Expanding foam was used to fill the gaps and secure the sample in place; the base of the sample was broken off to remove the block from the test pit. Whilst this method worked relatively well, the stress relief from the removal of the overburden material above the blocks caused the fissures to open, and several attempts were required to get a reasonably full sample box.

Figure 11. Removal of a block sample from the olive brown clay in TP1

Block samples were retrieved from the test pits to be used for further laboratory tests to investigate the strength and stiffness of the material. Due to the fissured nature of the material, these block samples could not be taken in the conventional manner where the material around the desired block is removed using a geological pick. A chainsaw was used to cut into the stiff clay, and the aim was to place a 200 x 200 x 200 mm metal box into the created cuts and remove the now structurally protected block sample. The process of cutting and removing the block samples is shown in Figures 11 and 12 for the samples of the olive brown and black clay taken from TP1 and TP2 respectively.

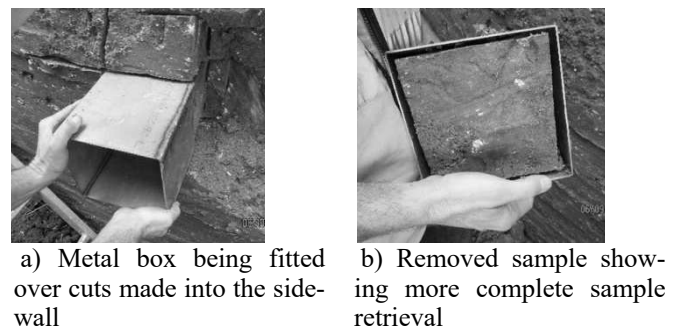
In an attempt to obtain better block samples in the second test pit, the chainsaw was used to cut directly into the pit sidewall as shown in the image sequence in Figure 12. This proved more successful, and once the metal box was in place, wedges of soil surrounding the sample could be removed allowing the sample to finally be removed.

Figure 12. Removal of a block sample of the black clay from the test pit side wall in TP2

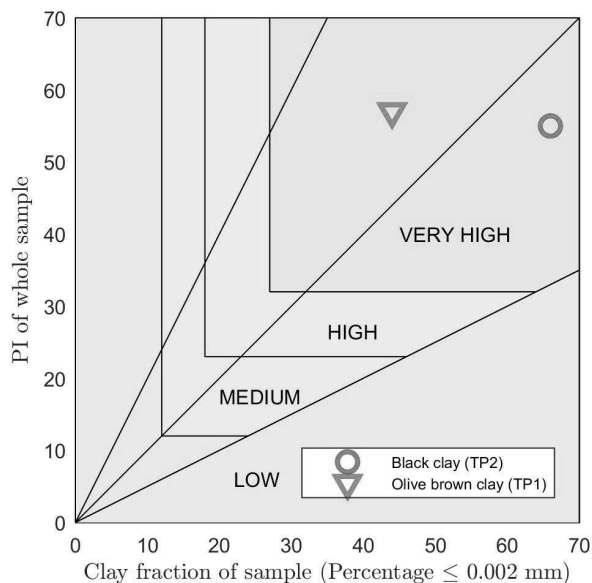
Figure 13 presents the activity chart as per Van der Merwe (1964) indicating potential expansiveness, based on the plasticity index (PI) of the whole sample and clay fraction. Both samples fall well within the very high expansive region, primarily due to the high PIs. The black clay has a significantly higher clay fraction than the olive brown clay, although the PIs are similar. This confirms the suitability of the material on site for the proposed field-testing.

Figure 13. Expansive potential of the clays on site plotted according to the activity chart of Van der Merwe (1964)

A sample of each of the black clay (surface deposits) and the olive brown clay (deeper clay deposits) were sent for grading and indicator tests. The black clay was classified as a high plasticity clay (CH), and the olive brown clay as a high plasticity silt (MH). The moisture contents of the clays were 34.2% and 36.5% respectively; the degree of saturation of the black clay was measured as 86.2 % from the average of eight samples. This high degree of saturation has important implications: this was sampled at the end of the dry season, and it is thus likely that many aspects of saturated soil mechanics can be applied in the analysis of the clay behaviour.

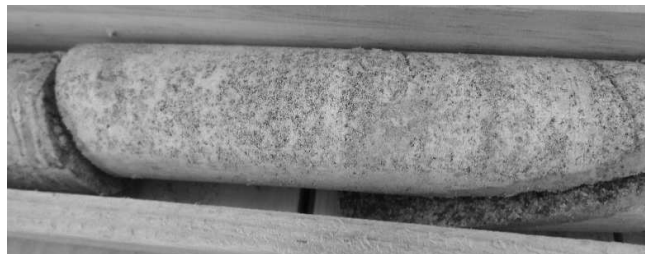
A thin transition was observed from the residual soil into the bedrock. The bedrock was described as hard to very hard rock, either norite or anorthosite; a photograph of a portion of the core is shown in Figure 14.

Figure 14. Portion of the residual norite core from 13.33 -14.02 m (BH1)
